Manhole Inspection Summary

Manhole # S39E2_018MH

Insp Date: **4/1/08 9:41 AM**

Location Address: **4150 Townsend Ave.**

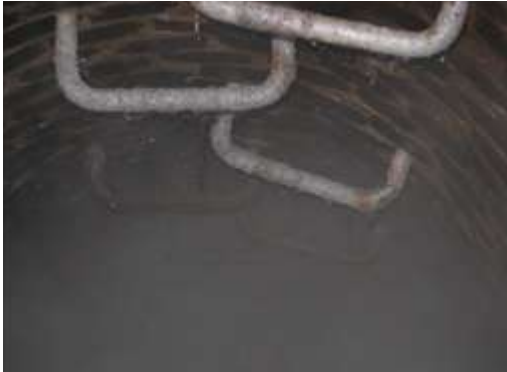
steps

Count: **9** Missing: **0** ☒ **Corroded**

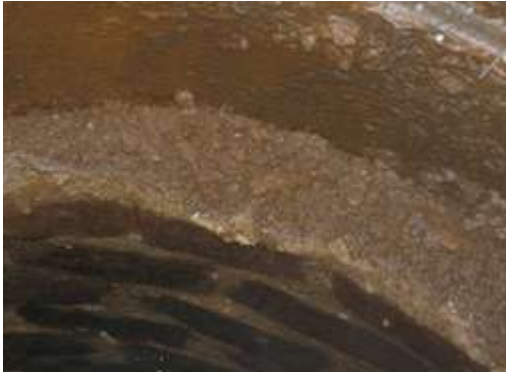
Defect 1

Offset: **3** (in.)

frame offset

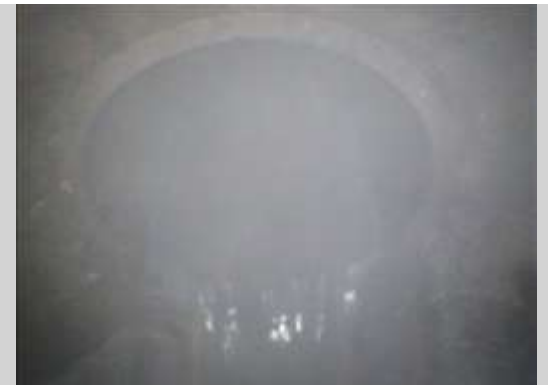
3 O'Clock Inflow

15 in. Circular Gravity Sewer
Pipe In @ 3 O'Clock

Pipe Height: **18** (in.) Rod and Bar (Angled)
Pipe Material: **Clay** ☐ Pipe Lined
Invert Depth: **13.99** (ft.) Flow Characteristics: **Fast**
Deposits: ☒ None ☐ Mud ☐ Sludge ☐ Debris ☐ Grease
Silt Depth: (in.) Deposits Extent:
Infiltration: **None** Pipe Seal Cond: **Sound**

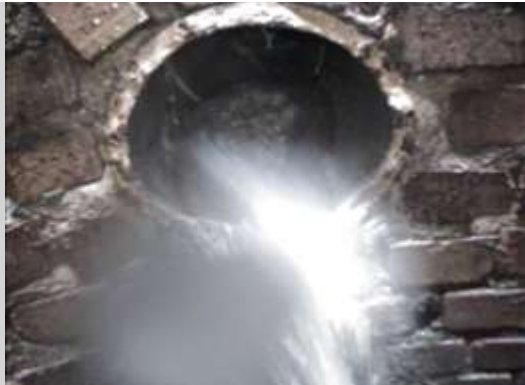
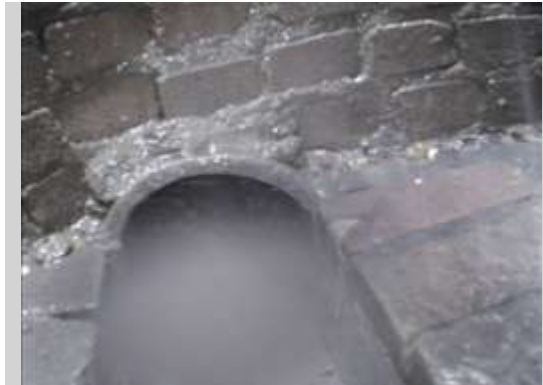
6 O'Clock Inflow

8 in. Circular Gravity Sewer

Pipe In @ 6 O'Clock

Drop In @ 6 O'Clock

Pipe Height: **8.4** (in.) Rod and Bar (Angled)

Invert Depth: **8.59** (ft.) Flow Characteristics: **Turbulent**

Drop: **Outside** Rod and Bar

Angled: **Yes** Reading: **13.04** (ft.)

Inv Depth: **14.04** (ft.)

Drop Condition: **Open**
